New Hampshire Volunteer Lake Assessment Program

2002 Interim Report for Lake Winona New Hampton

Lake Winona, New Hampton

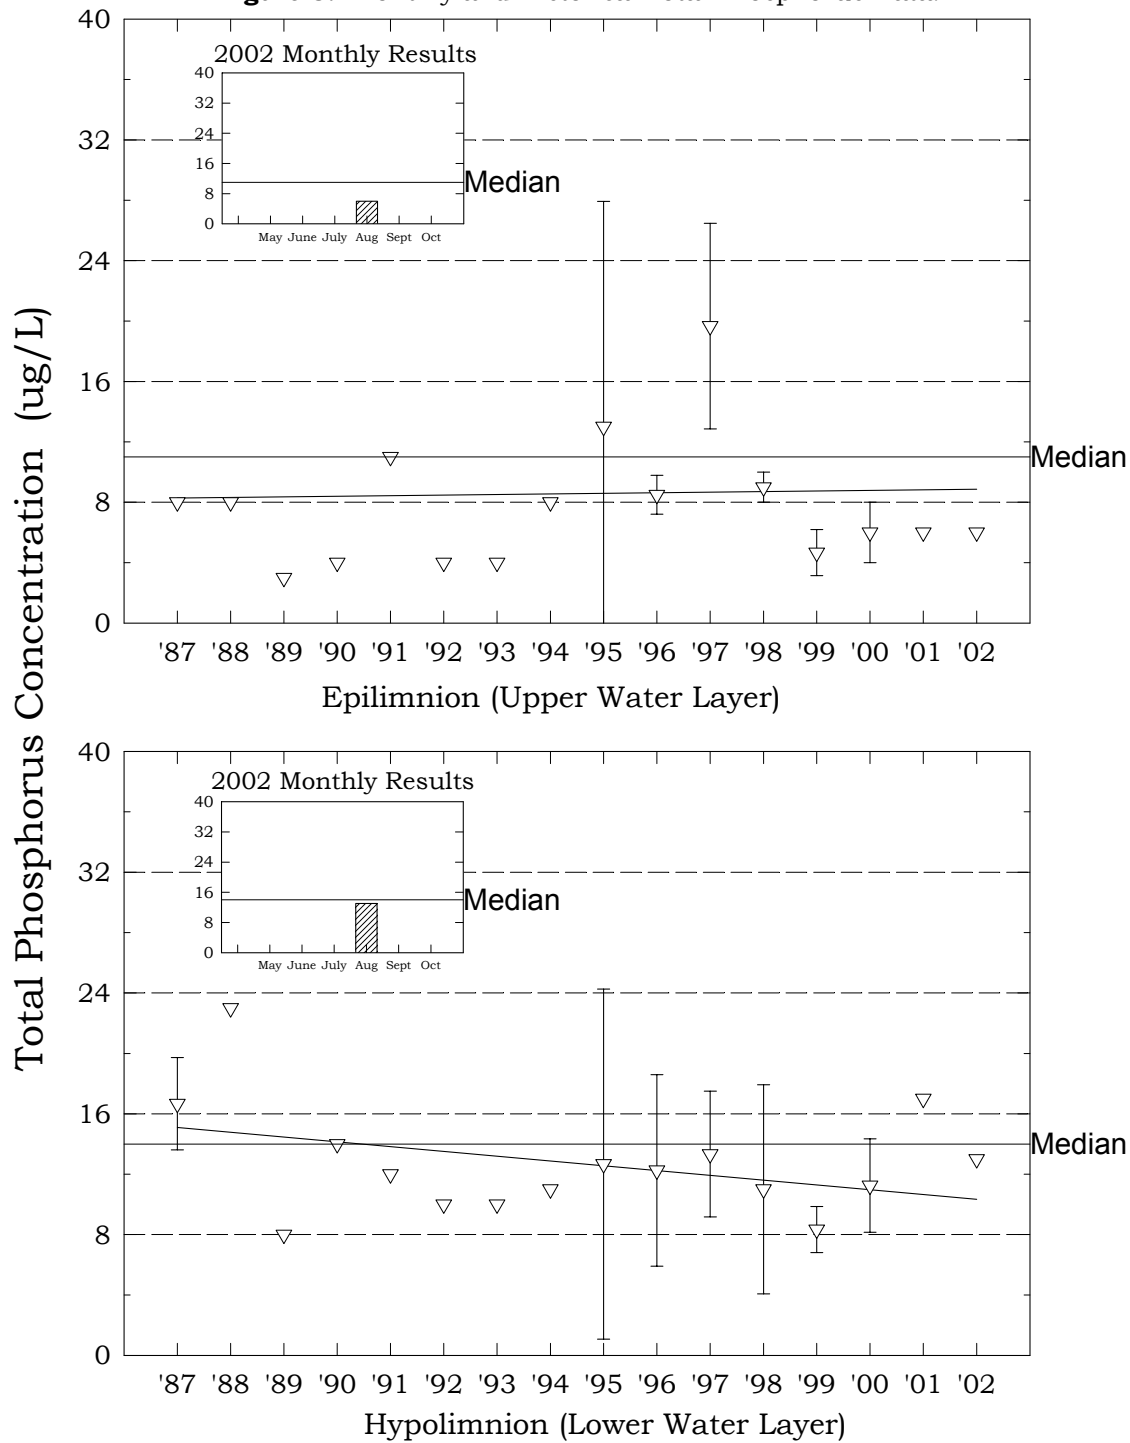
Figure 3. Monthly and Historical Total Phosphorus Data.

- **Figure 3 and Table 8:** The graphs in Figure 3 (Appendix A) show the amounts of phosphorus in the epilimnion (the upper layer) and the hypolimnion (the lower layer); the inset graphs show current year data. Table 8 (Appendix B) lists the annual maximum, minimum, and median concentration for each deep spot layer and each tributary since the lake/pond has joined the program.

The historical data for the epilimnion (the top inset graph) show that the total phosphorus concentration in August was ***much less than*** the state median.

The historical data for the hypolimnion (the lower inset graph) show that the total phosphorus concentration in August was ***slightly less than*** the state median.

Overall, visual inspection of the historical data trend line for the epilimnion (the upper graph) and the hypolimnion (the lower graph) shows ***a variable*** total phosphorus trend, which means that the concentration has ***fluctuated*** in the epilimnion since monitoring began in 1987.

One of the most important approaches to reducing phosphorus loading to a waterbody is to continually educate watershed residents about its sources and how excessive amounts can adversely impact the ecology and value of lakes and ponds. Phosphorus sources within a lake or pond's watershed typically include septic systems, animal waste, lawn fertilizer, road and construction erosion, and natural wetlands. If you would like to educate watershed residents about how they can help to reduce phosphorus loading into the lake/pond, please contact the VLAP Coordinator.
